CAERNARFON HARBOUR TRUST - AIDS TO NAVIGATION UPDATE

01/05/2025

SUMMARY OF SCHEDULE OF INSPECTION / REPLACEMENT FOR A TO N

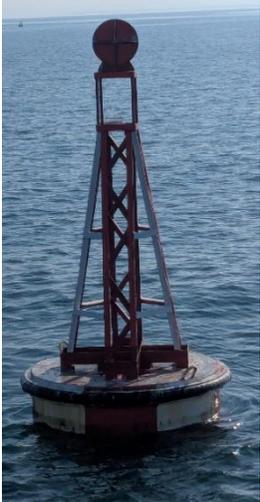
A to N Name / Type	Disc	Ground Tackle	Depth of water CD	Last Inspection / <i>Work required</i>	Light (New / Due for renewal)	Notes / photographs
Fairway Buoy <i>Off Caernarfon Bar</i>	2019 steel buoy designed and constructed by CHT	27.5m 38mm Open Link AC 14 Anchor 800Kg All shackles fully welded	7.64	Repainted and deployed 13/3/25 Recover 09/2025 Prepare for redeployment 03/2026	Carmanah 660 2022-2032

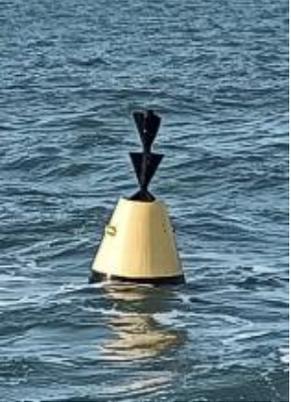
<p>South West Rock Buoy <i>South Cardinal buoy off Llanddwyn</i></p>	<p>Buoy type = steel</p>	<p>Mooring = 15m of 19mm mid link chain to train wheel sinker.</p>	<p>8.5</p>	<p>Repainted and deployed 13/3/25</p>	<p>N/A</p>

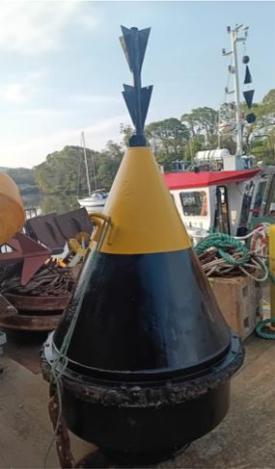
<p>North East Rock Buoy <i>South Cardinal buoy off Llanddwyn</i></p>	<p>Buoy type = steel</p>	<p>Mooring = 15m 19mm mid link chain going to train wheel sinker.</p>	<p>2.02</p>	<p>Repainted and deployed 13/3/25</p>	<p>N/A</p>

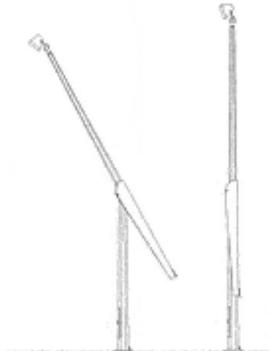
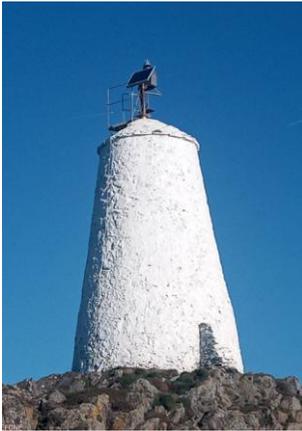
<p>Llanddwyn Light</p>	<p>Old Stone Tower</p>	<p>N/A</p>	<p>N/A</p>	<p><i>Tower Painted 2023</i> Inspection 09/2025</p>	<p>NEW 2015 <i>Sealite Apollo</i></p>

<p>The metal work atop the tower is showing significant signs of deterioration and will need replacing within the next two years. I am currently considering a cantilever street light post.</p>

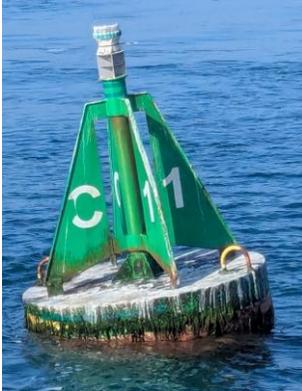
<p>C1 <i>Starboard hand buoy</i></p>	<p>Buoy New 2007 Refurbished Dec 2023 Buoy type = steel</p>	<p>Mooring = 30M ~28mm 2 X 400kg train wheel sinker</p>	<p>5.38</p>	<p>Inspected 2024 Inspection 03/2025 Replacement C1 is in the shed being redressed. Anticipate deployment early May.</p>	<p>Carmanah 650 2014</p>

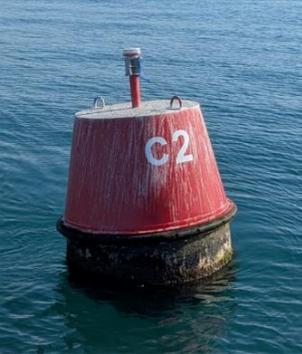
<p>C2 <i>Port hand buoy</i></p>	<p>Refurbished buoy May 2013. Ground tackle renewed in 2012. Buoy type = steel</p>	<p>Mooring = 27.5m 28mm studlink 400kg train wheel sinker</p>	<p>0.34</p>	<p>NEW mooring equipment 03/2024 Inspection 03/2025 Inspect 09/2025</p>	<p>Carmanah 660 2018</p>

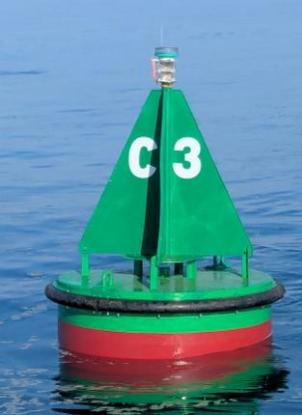
<p>C3 <i>Starboard hand buoy</i></p>	<p>New Buoy December 2014 Ground tackle new December 2023. Buoy type = steel buoy</p>	<p>Mooring = 30m ~28mm 400kg train wheel sinker</p>	<p>1.7</p>	<p><i>New mooring equipment 03/2025</i> Inspection 03/2026</p>	<p>Carmanah 660 2024</p>

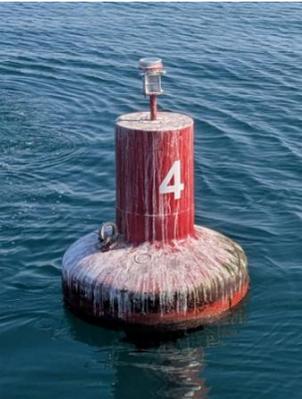
<p>C4 <i>Port hand buoy</i></p>	<p>Refurbished buoy and new ground tackle in June 2022. Buoy type = steel</p>	<p>Mooring = 30m ~ 28mm 400kg train wheel sinker</p>	<p>1.8</p>	<p>Needs bringing ashore for refurbishment. <i>Inspected 11/04/25</i></p>	<p>Carmanah 660 2022</p>

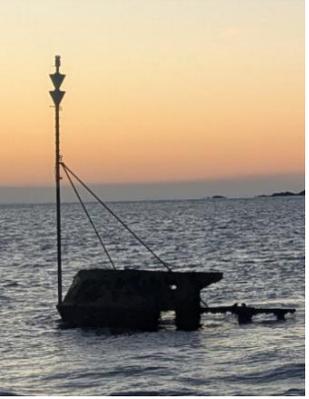
<p>Grampian castle Fixed South cardinal</p>				<p>Fabricated inhouse and installed 01/04/25 Inspect 01/05/26</p>	<p>Carmanah 660 2025</p>

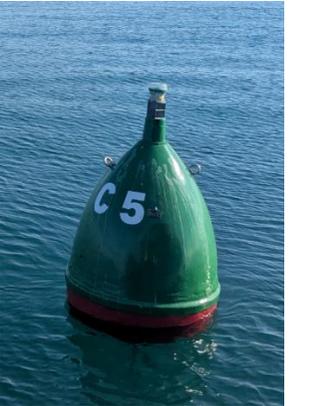
<p>C5 <i>Starboard hand buoy</i></p>	<p>New Buoy in May 2017 Buoy type = Steel</p>	<p>Mooring = 30m ~ 28mm 400kg train wheel sinker</p>	<p>1.93</p>	<p>New 03/2024 Inspect 03/2025</p>	<p>Carmanah 650 2017</p>

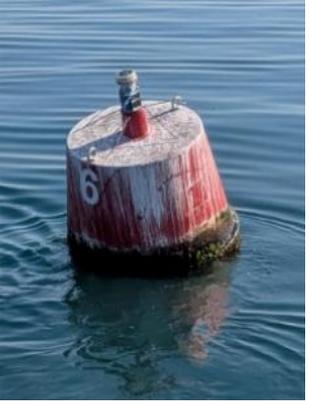
<p>C6 <i>Port hand buoy</i></p>	<p>New Buoy in Sep 2008 with new ground tackle. Buoy type = Tideland SB98 - Polyethylene</p>	<p>Mooring = 30m ~ 28mm 400kg train wheel sinker</p>	<p>2.3</p>	<p>Needs bringing ashore for refurbishment. <i>Inspected 11/04/25</i></p>	<p>Carmanah 650 2014</p>

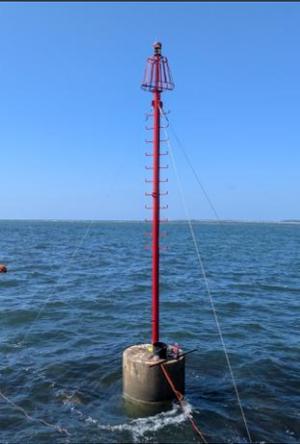
<p>Mussel Bank Fixed Perch</p> <p><i>Port hand buoy (Discontinued)</i></p>	<p>Perch</p>			<p>Fabricated in house, Installed 29/08/2024</p> <p>Inspect 01/08/2026</p>	<p>Carmanah 660 2024</p>

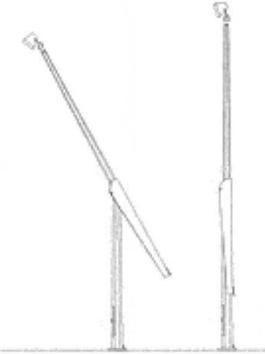
<p>Abermenai Point</p> <p><i>Sectored light</i></p>	<p>N/A</p> <p>New light and solar unit fitted 19/11/2010 at a total cost of £3,270.</p>		<p>N/A</p>	<p><i>Wooden post of unknow age. Anticipate 3-5 years' service.</i></p> <p><i>I am currently considering a cantilever street light post.</i></p> <p><i>Inspected 2023</i></p>

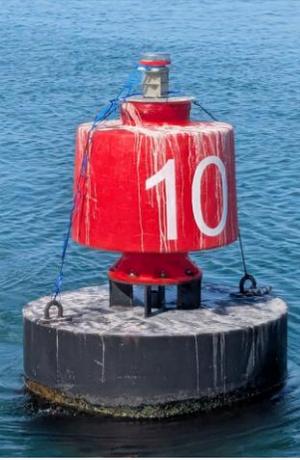
<p>C10 <i>Port hand buoy</i></p>	<p>Refurbished buoy deployed Sep 2009 with new ground tackle. Buoy type = GRP</p>	<p>Mooring = 27.5m 28mm stud link 400kg train wheel sinker</p>	<p>2.1</p>	<p><i>New mooring equipment in 2022</i></p> <p>Needs cleaning</p> <p><i>Inspect 09/2025</i></p>	<p>Carmanah 660 2021</p>

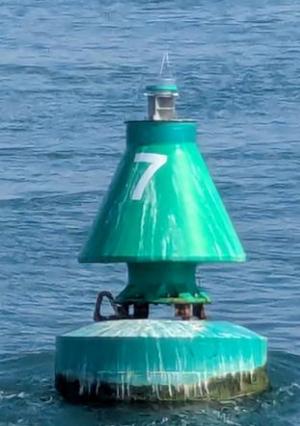
<p>C7 <i>Starboard hand buoy</i></p>	<p>New buoy and ground tackle in Feb 2008 Buoy type = Mobilis BC1242 - Polyethylene</p>	<p>Mooring = 30m@ 28mm 400kg train wheel sinker</p>	<p>2.3</p>	<p>Inspected 05/2024 Inspect 05/2025</p>	<p>Carmanah 660 2023</p>

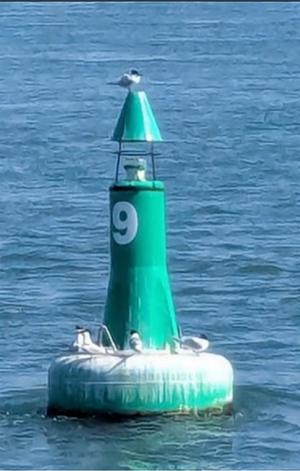
<p>C9 <i>Starboard hand buoy C'fon</i></p>	<p>New buoy and ground tackle in Sept 2014 Buoy type =</p>	<p>Mooring = 30m@ 28mm 400kg train wheel sinker</p>	<p>3.58</p>	<p>New Mooring equipment 2023 Inspect 4/11/2024 Inspect 09/2025</p>	<p>Carmanah 650 2017</p>

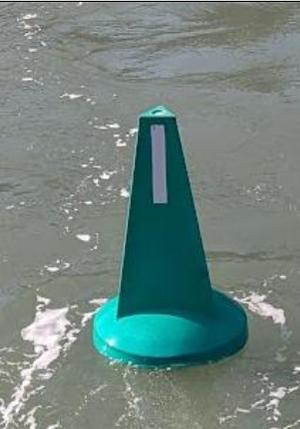
<p>Pillar Buoy No.1 (nearest swing bridge) <i>Starboard hand buoy</i></p>	<p>New buoy in Sept 2014 Buoy type = Polyethylene Sealite SLB 600</p>	<p>Mooring = 4.5M of 24mm Robline to 2M of 19mm chain to 400kg train wheel sinker</p>	<p>0.5</p>	<p>Inspected 2023 Inspected 09/2024 Inspect 09/2025</p>	<p>N/A</p>

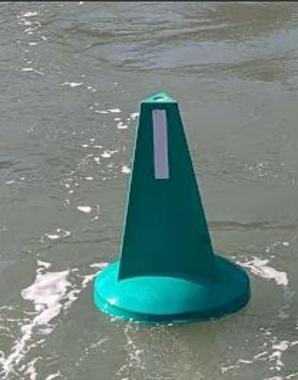
Pillar Buoy No.2 <i>Starboard hand buoy</i>	New buoy in Sept 2014 Buoy type = Polyethylene Sealite SLB 600	Mooring = 4.5M of 24mm Robline to 2M of 19mm 400kg train wheel sinker	0.5	Inspected 2023 Inspected 09/2024 Inspect 09/2025	N/A

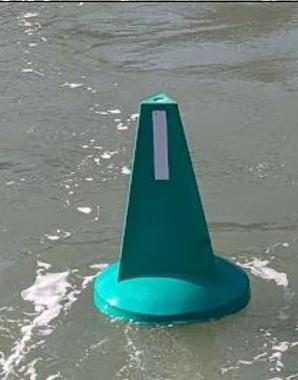
Pillar Buoy No.3 <i>Starboard hand buoy</i>	New buoy in Sept 2014 Buoy type = Polyethylene Sealite SLB 600	Mooring = 4.5M of 24mm Robline to 2M of 19mm chain to 400kg train wheel sinker	0.5	Inspected 2023 Inspected 09/2024 Inspect 09/2025	N/A

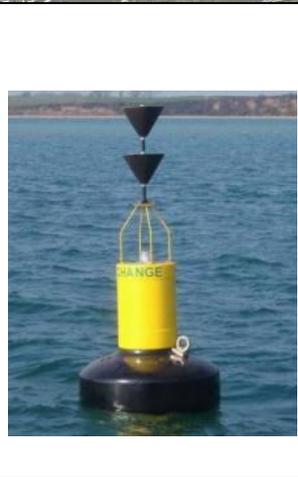
Change Buoy <i>South Cardinal buoy</i>	Refurbished buoy deployed in March 2011 (ground tackle = May 2008) Buoy type = Tideland SB- 98P - Polyethylene	Mooring = 30m@ 28mm 400kg train wheel sinker	6.09	New Moorings equipment 2023 Inspected 09/2024 Inspect 09/2025	Carmanah 650 2009

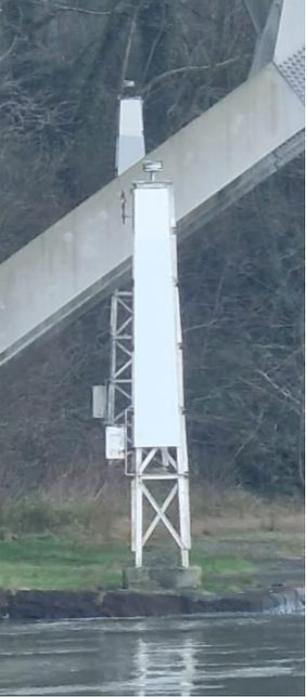
Leading Lights <i>Britannia Bridge</i>	N/A			Inspected 08/2024 Inspected 31/1/2025	Lights = Carmanah 660 x 2 2019

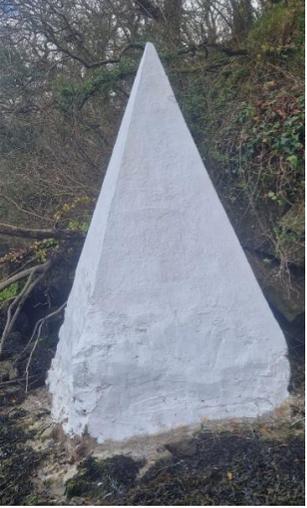
Pyramid (Bn) (Swellies)	N/A			Painted 26/3/25 Inspect 26/3/25	N/A

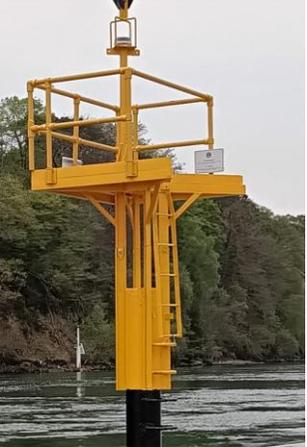
<p>Swelly Rock</p> <p><i>Lighted Beacon</i> <i>South Cardinal</i></p>	<p>N/A</p>			<p>Inspected Replaced access platform and ladder 21/03/25</p>	<p>New Light Carmanah 660 2025</p>

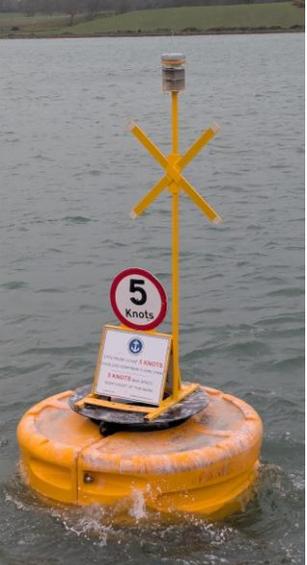
<p>Speed Limit marker SW</p>	<p>Hydrosphere</p>	<p>Mooring = 27.5m@ 28mm</p> <p>400kg train wheel sinker</p>		<p>New install 21/03/25</p>	<p>New Light Carmanah 660 2025</p>

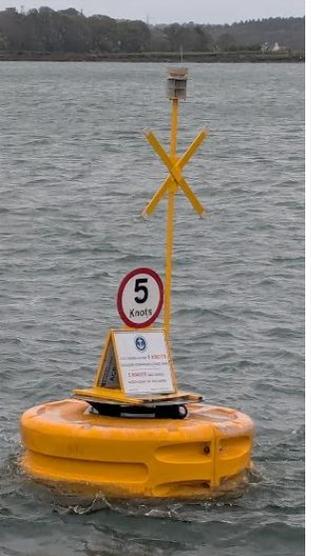
Speed Limit marker NE	Hydrosphere	Mooring = 27.5m@ 28mm 400kg train wheel sinker		New install 21/03/25	New Light Carmanah 660 2025
