HARBOUR MASTERS MONTHLY REPORT 5th February 2025**PMSC**

NAVIGATION

Navigational Work in the Swellies

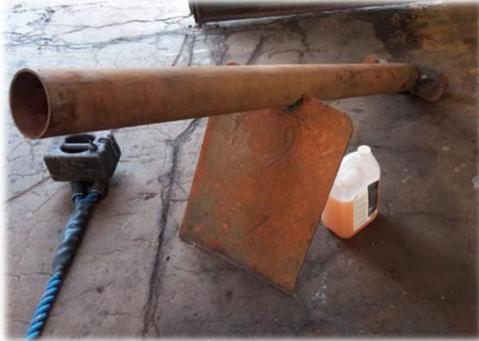
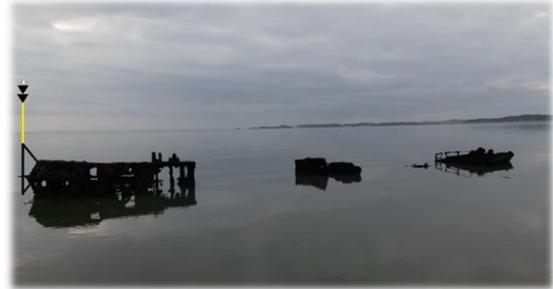
The receiving base tube for the new South Cardinal perch for the Grampian Castel has been fabricated onsite to ensure correct fitment and arrangements to Galvanise have been made.

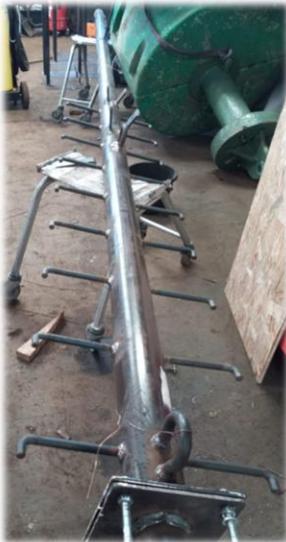
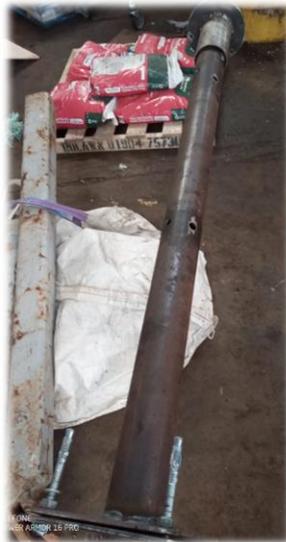
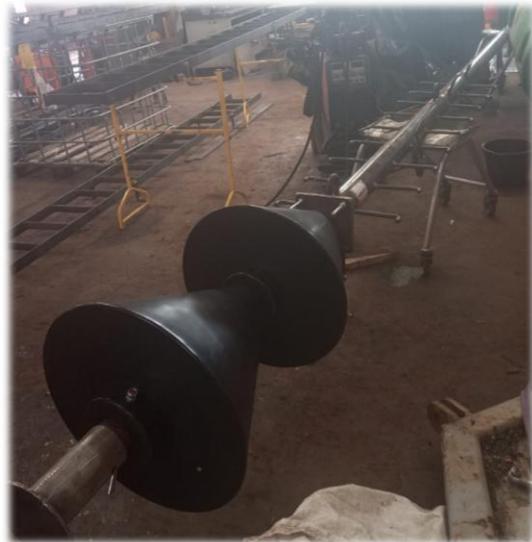
The perch its self has also been Fabricated and it is also ready for to be sent for galvanising.

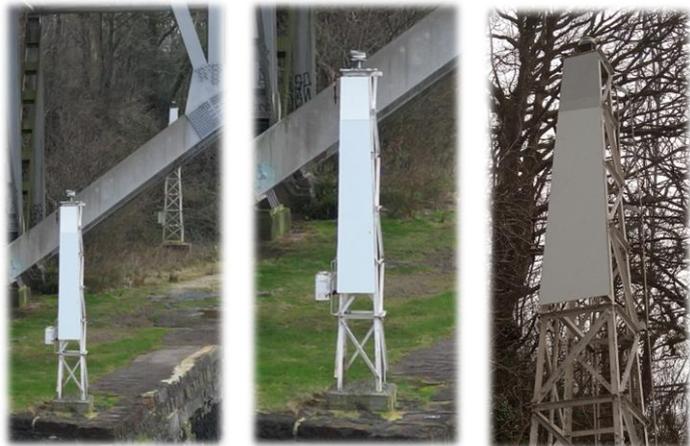
The Transit “Leading Lights” beneath Britannia Bridge have been cleaned and the lights are in good order.

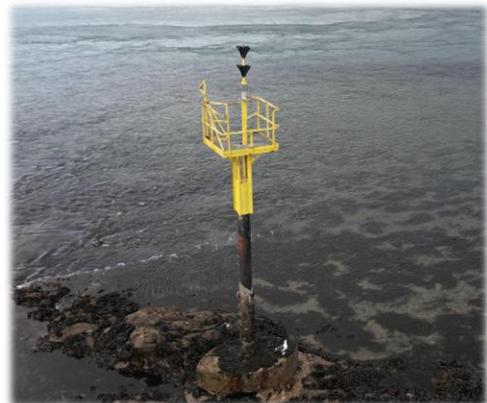
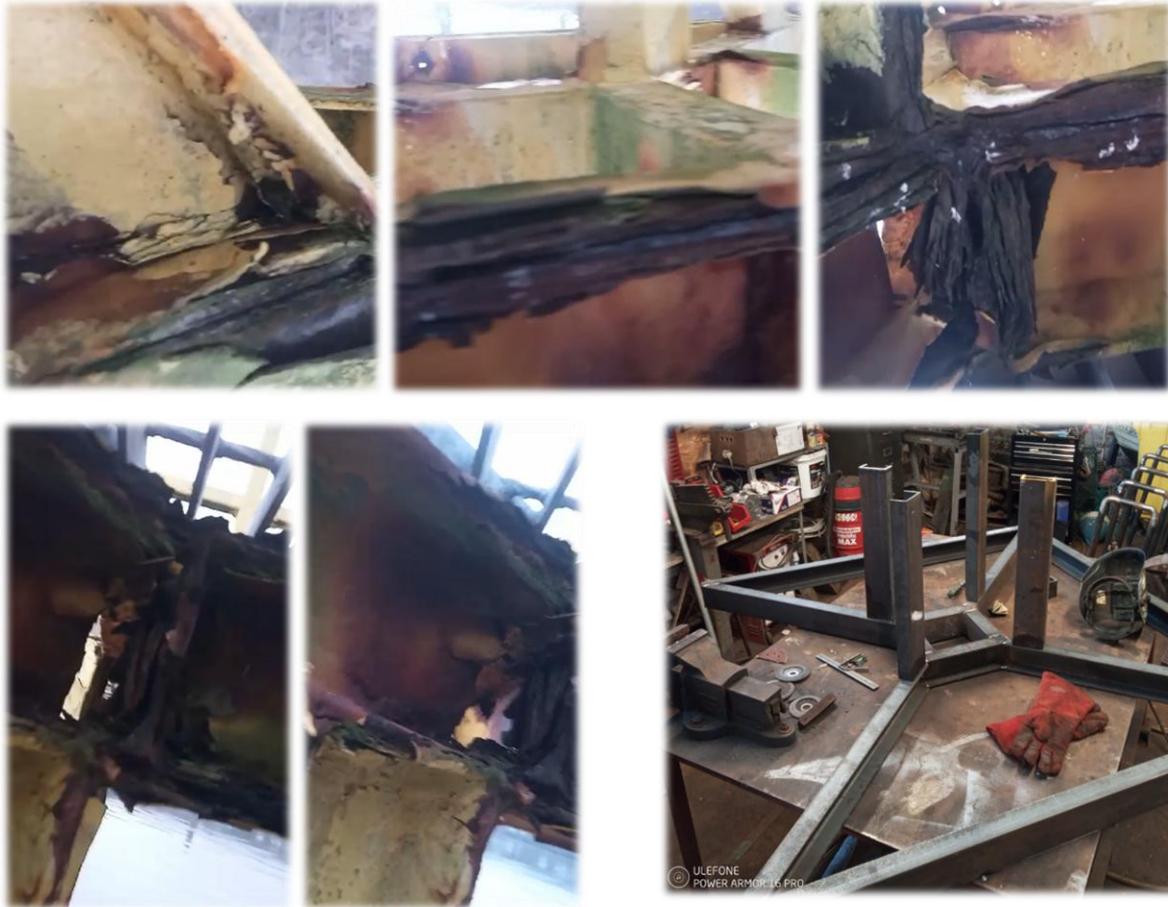
Swelly Rock South Cardinal, the platform and top section including the safety rails are now showing significant corrosion and required immediate attention. There is no immediate risk that the AtoN will fail to demonstrate is appropriate characteristics. The upright and access ladder are also in good condition. However, it is becoming unsafe to access the platform.

A replacement platform has been fabricated and prepared for galvanising and plans are being undertaken to replace the platform in the coming months. More information will be made available through NtoMs.
